Retrofitting and Investigation of Performance of Box Girder Bridge Using Glass Fiber Reinforced Polymer (GFRP)

Abstract— Namosain box-girder bridge was located in Kupang City at Province of Nusa Tenggara Timur (NTT). This bridge was built in 2008 and recently suffered any cracks on the bottom of slab of the box girder during its service load. This bridge was retrofitted using *Glass Fiber Reinforced Polymer (GFRP)* to reinstate and improve its performance against live loading. Two layers of GFRP, one in longitudinal direction and another in transverse direction was bonded on the bottom of box girder using epoxy resin.

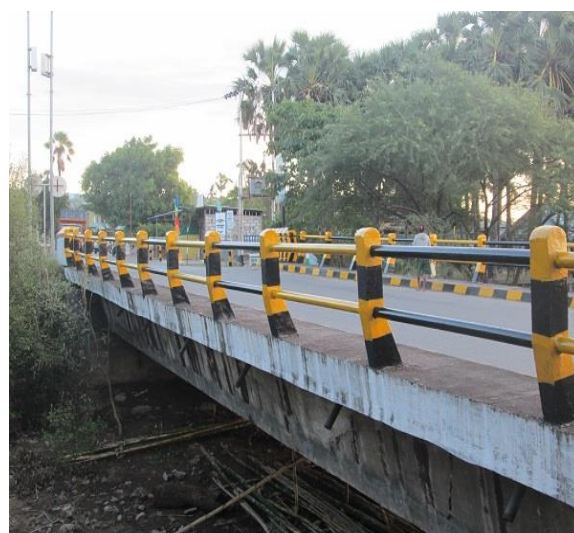
Figure. 2 Namosain box-girder bridge lay near the sea.

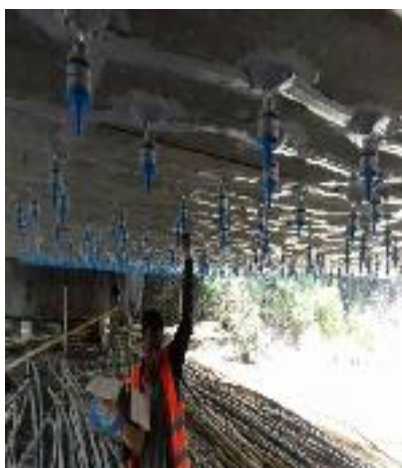
Figure 4. Cracks repairing process.

Before bottom slab of box girder bridge was retrofitted using GFRP, any cracks was repaired using epoxy injection technique. Firstly, cracks were cleaned from dust and grease with wire brush and blown up the cracks with compressor there. Then cracks slit were capped with bond compound and leave some spot for attaching Unifor port crack injector system for better penetration resin injection into the cracks (Fig.3). The injector system utilised a low and constant pressure method to inject epoxy resin into fine cracks of all kinds of concrete structure. The system maintains the pressure of the grouting material to at least 1.0 kgf/cm^2 and limits its maximum to 3.0 kgf/cm^2 . It needed at least 12 hours curing after the injection process finish to allow cracks closed and then Unifor system and seal can be removed using grinding.

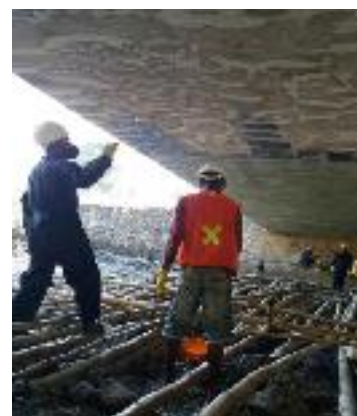
Figure 6. Strengthening bottom slab of box-girder bridge using GFRP Tyfo SEH51A composite

After whole cracks repair process were completely finished, strengthening of the bottom slab of the box girder bridge was started. Glass fiber sheet (Tyfo type SEH51A) combined with Tyfo S Epoxy which has a two-component epoxy for bonding application were used as composite system for external reinforcement for strengthening bridge. This GFRP composite has ultimate tensile strength of 575 MPa, maximum elongation of 2.2% and tensile modulus of 26.1 GPa [3]. Procedure for strengthening of bottom slab of box-girder bridge was described following. Firstly the required surface for strengthening was cleaned, dried and free of protrusions or cavities. Next, glass fiber fabric was cut as required length of 6.275 m and 1.28 m width. Cutting size of fabric fiber and orientation applied to the concrete slab surface showed in Fig.4. This dry fabric fiber was laid on wide plastic sheet to saturate with epoxy resin which has been prepared. The required surface length for strengthening was also painted with epoxy resin using large roll. Then the saturated laid fiber sheet was attached to the painted surface and using roll this sheet pressed to remove air trapped below the fiber fabric. This work was started from the left end bridge support along 6.275 m (Fig.5). The wide part with length of 6.275 m was finished first before continued along the bridge span. Overlap length of cutting fiber sheet was 100 mm. One layer of glass fiber embedded with epoxy was attached first to the bottom surface of the box beam along the bridge span of 24.8 m. Then the second layer with length of 6 m was attached in transverse direction or along wide of the bridge. It started from the left bridge support as well. Overlap 100 mm was also applied for the next 6 m length in transverse direction. The curing time for strengthening application need at least 30 hours.

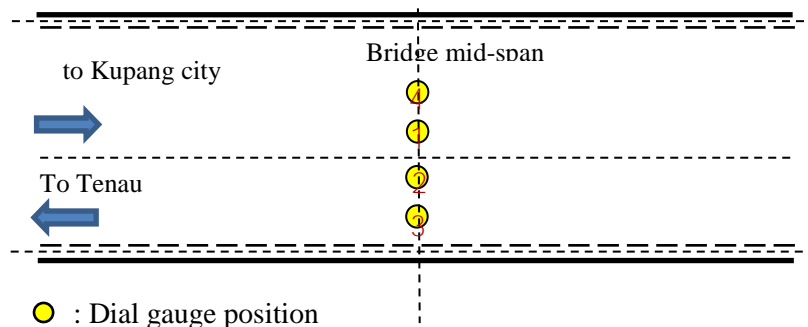
Figure 9. Position of dial gauge seen from top view.

Fig. 7 shows each rear wheel of trucks move backwards about 43 cm from mid-span. Therefore mid-span is located between each rear wheels with load resultant from each truck. Maximum moment occurs below the rear truck. This gives slightly different maximum moment compared with combination 1, however this gives similar deflection with combination 1. Four dial gauges were located at mid-span of the bridge to measure deflection occur during loading test. Those position were depicted in Fig.8. At beginning, those all dial gauges were assumed to give similar result for deflection, however it gave different result between deflection at middle section of slab and deflection of slab near the edge of the box girder on strengthened bridge. Fig 9 shows position of dial gauges

attached to the bottom slab of box-girder bridge. Fig. 11 and 12 shows position of rear wheels according to the loading combination 1 and combination 2.

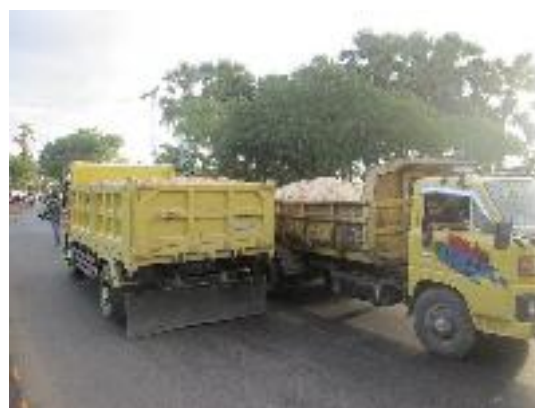
Figure 11. Two trucks at loading position on box-girder bridge that tested.

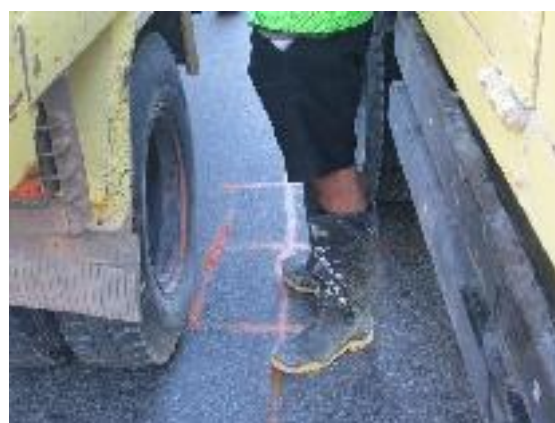
Figure 13 Position of rear wheel of truck on loading of combination 2
