Evaluation of Pedestrian Way's Comfort

Case Study: Jl. Z. A. Pagar Alam, Bandar Lampung

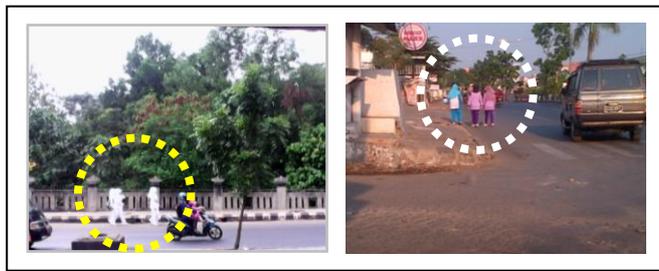
The phenomenon that occurs in this education area, The number of pedestrians who uses the road on their activity. This case certainly disturbs the use of vehicle and danger for the pedestrians.

Figure 2. The Use of The Road
Source: Author

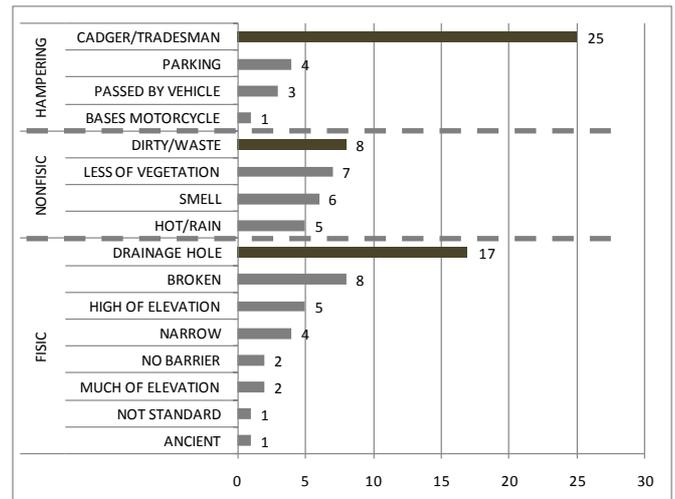
All respondents stated that the pedestrian way along the ZAPA Street is uncomfortable (less comfortable). This indicated that respondents felt discomfort on existing condition of the pedestrian way. Factors of discomfort derived from the content analysis showed that there were three categories: physical factors, non-physical factors, and obstacles. The diagram below showed that the most mentioned discomfort by respondents were drainage holes (physical factor), dirty (non-physical factors), as well as the street merchants / vendors (obstacles).

Diagram 1. Diagram of Distribution of Comfort Factor towards Pedestrian Way
Source: Author

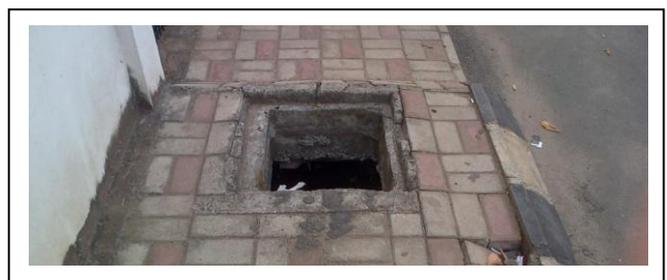
Discomfort caused by the drainage holes was found due to the large number of drainage holes along the ZAPA Street. The presence of many uncovered holes affect the pedestrian safety level which can lead to accidents (slipping). The level of harm is high because the drainage has a significant depth

Figure 3. Drainage Hole
Source: Author

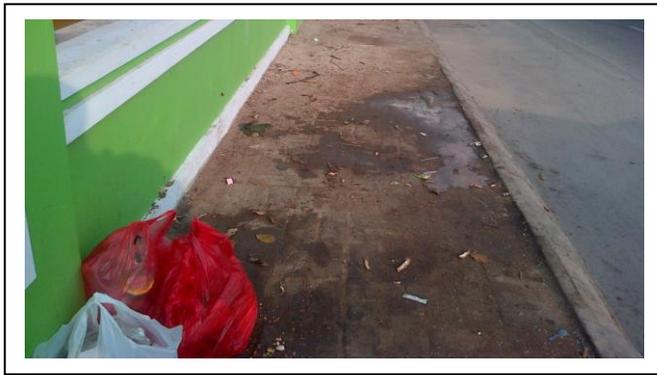
Discomfort caused by the dirtiness of the walkway was found due to the commercial activities by traders at night leaving traces of their activities. Left-over garbages such as food waste, burning stains, and also the scent. This condition

causes discomfort on the pedestrian due to its visual and non-visual traces.

Figure 4. Visual and Non-visual Waste
Source: Author

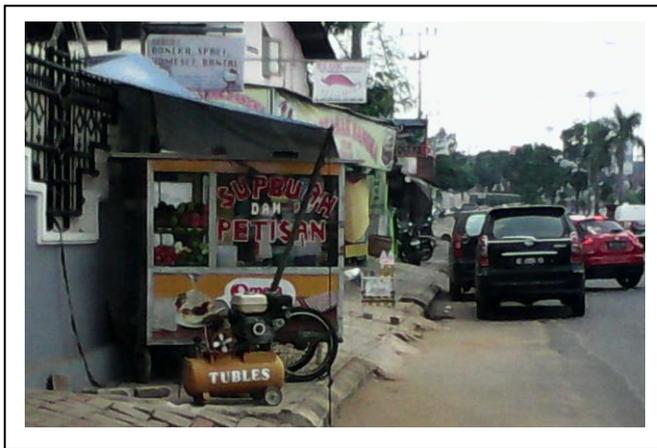
Discomfort caused by the street merchant (PKL) was found in the situation when the pedestrian has to make extra effort to hinder or avoid them. This certainly raised significant fatigue. In addition, it is also a dangerous situation for the pedestrian because of potential contact with the motorised vehicle. Thus, the level of danger caused by the presence of street merchant is quite high.

Figure 5. Street Vendor
Source: Author

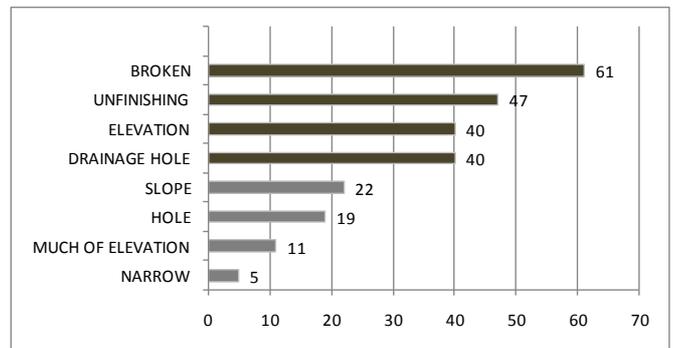
Direct observation indicated that the most common physical conditions that caused discomfort were damage, unfinished, elevation, and drainage holes.

Based on the following diagram of data distribution of physical conditions, those four conditions were the most often mentioned by respondents. This indicated that respondents felt more or the encountered most frequent those conditions when passing through it.

Diagram 2. Distribution of Physical Condition
Source: Author

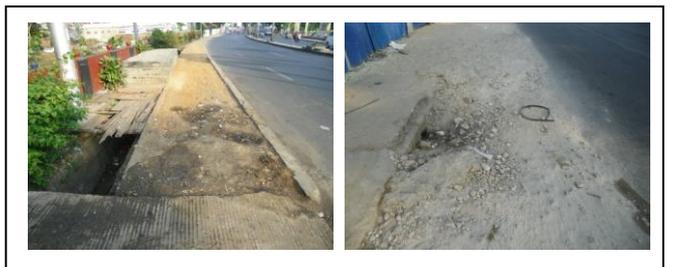
Another discomfort was caused by the presence of unfinished pedestrian spot. The unfinished condition was seen in the form of rough concrete blocks and also totally unfinished (soil / sand / gravel). It was considered to be very disruptive to pedestrian activity by potentially causing slipping (falling).

Figure 6. Unfinishing Condition
Source: Author

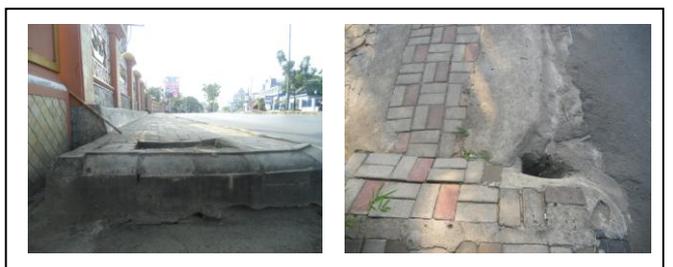
The next discomfort was the elevations which exceed the height of the standards of comfort for elevation. The height of the comfortable elevation is in the range of 16-18 cm for Indonesian society. While the existing elevation of the pedestrian area reaches more than 30 cm. The difference in number was very significant in affecting pedestrian comfort.

Figure 7. The High Elevation Condition
Source: Author

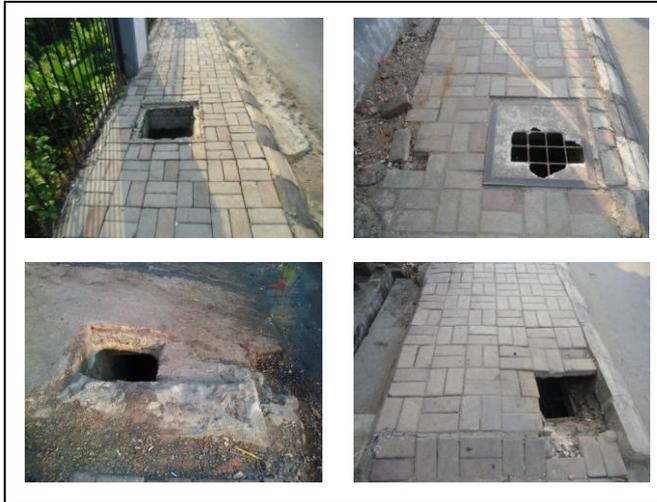
The last discomfort that was encountered is the number of drainage holes. In the ZAPA Street, which has the length of

2.5 km or two sides of the pedestrian areas which has the length of five kilometres, there were 40 drainage holes. Thus, on average, there was a drainage hole in every 125 cm. In the drainage holes which were casted, the cause of this condition could not be known with certainty. This condition could be caused within the construction of pedestrian or by other irresponsible party which intentionally take them for certain purposes. Other conditions showed that the drainage holes were open because of damage, low quality concrete, and finishing without a cover.

Figure 8. Drainage Hole Condition
Source: Author

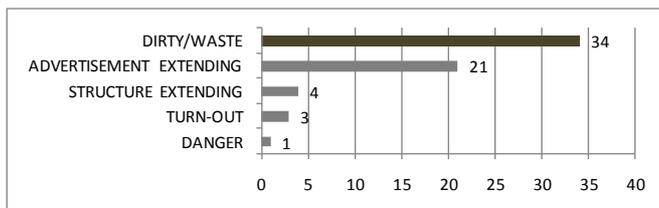
Distribution diagram of non-physical condition data distribution diagram below showed the most common non-physical discomfort is the dirty condition of the pedestrian area. The dirtiness of pedestrian area also caused bad odour. This was similar to condition that most of the respondents mentioned dirty as the most felt uncomfortable factor.

Diagram 3. Distribution of Nonphysical Condition
Source: Author

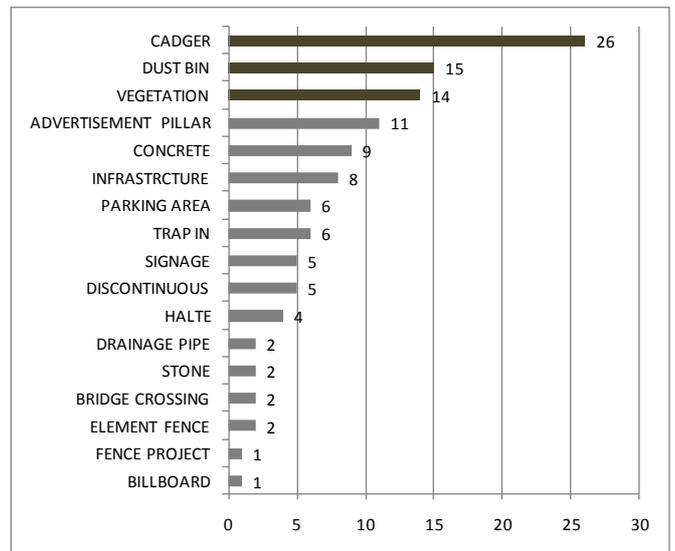
Data distribution diagram of obstacle condition below shows the most common encountered obstacles such as street merchants (vendors), trash bins, and vegetation. The number of merchants met by the authors during observation was also in line with the respondents' answers. This indicated that respondents were very disturbed with the presence of street merchants when walking in a pedestrian area.

Diagram 4. Distribution of Restriction Condition
Source: Author

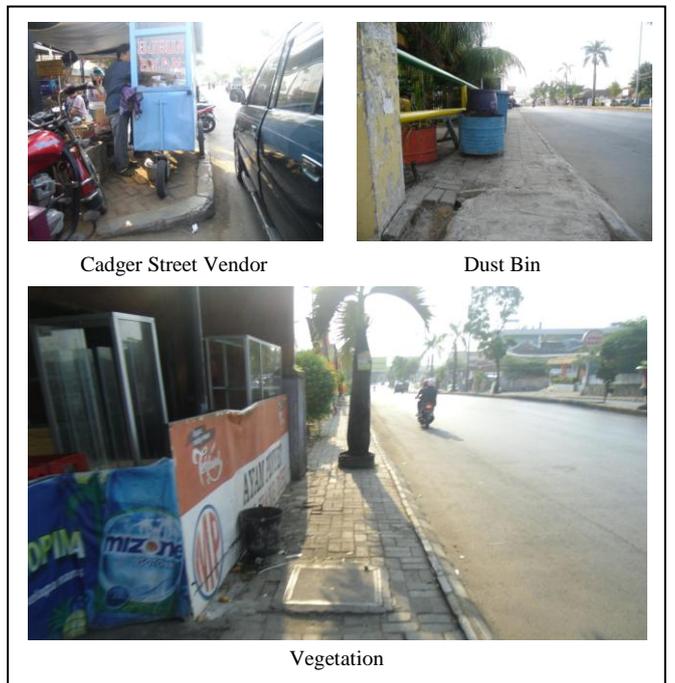
In regard to vegetation condition, authors found that there were vegetation planted in the middle of the pedestrian and the existence of the pot (permanent and non-permanent) in the area. This was presumably due to the widening of the road which has shifted the pedestrian area.

Figure 9. Obstacle Condition
Source: Author

In the other hand, related to the presence of trash bin, the obstacle was indicated by the placement of the trash bin in the pedestrian area by building users and merchants in the surrounding. So that this problem can be easily solved by the concerned parties through direct communication with users or merchants around.
